## SUSSEX VILLAGE HALL EXISTING CONDITIONS STUDY

This evaluation was conducted by a team of professionals from Plunkett Raysich Architects and Mortenson Construction. The team visually reviewed the building, researched available building plans, and reviewed current building codes as necessary to gather information. The building evaluation was non-destructive. Comments made are based on exposed, observed conditions.

The Sussex Village Hall was originally constructed as a public grade school in 1922. The school facility was renovated in 1961. The school was closed in 1979. In 1989, the facility was renovated and became the Village Hall.

The summary provided below and in the following photographs identifies items observed by Plunkett Raysich Architects during a site visit conducted on Wednesday, April 28, 2010.

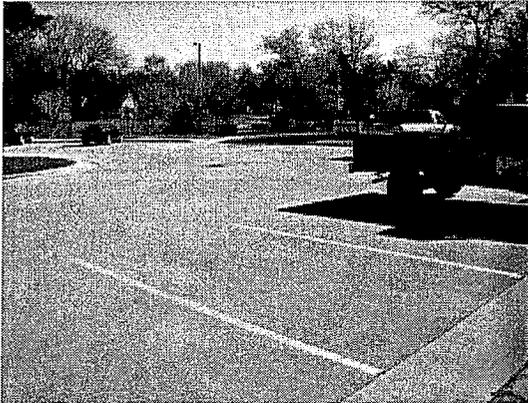
1. The existing parking lot lies to the north and west of the building and is shared with the Sussex Library.
2. Pavement appeared to be in generally good condition and adequately drained. Sealing and restriping should be performed in the near future. Refer to photo 2.0.1.

2.0.1 Existing parking lot

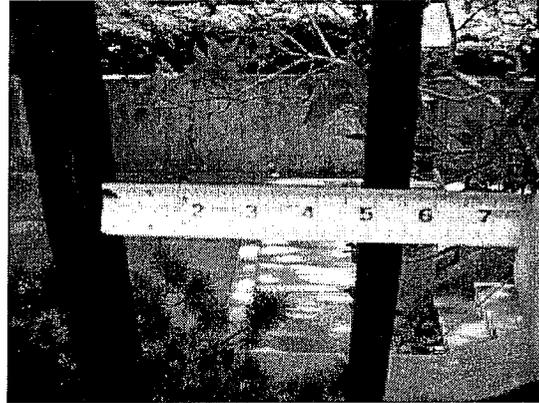
1. Picket spacing was observed to be greater than current code allowance. Refer to photo 2.0.2.
2. Guardrail baluster pockets in concrete walls were observed to be generally open and unsealed. All pockets should be cleaned, steel guardrails cleaned and painted and pockets filled with backer rod and sealant. Refer to photo 2.0.3.

2.0.2 Picket spacing too large

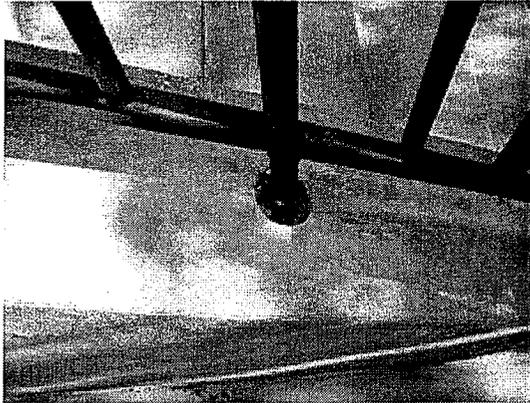
2.0.3 Baluster pocket open

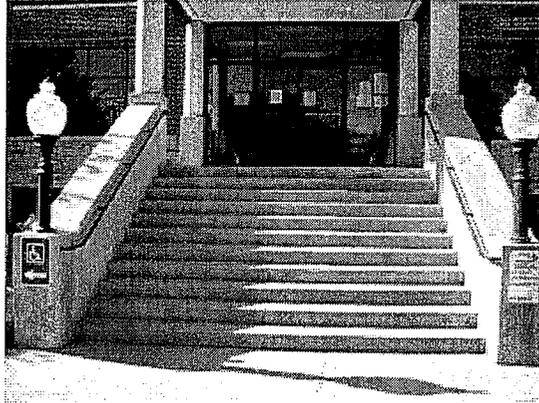
1. An intermediate handrail at the front entry stair is likely required to comply with building egress code. Code requires all portions of the stairway width required for egress capacity be within 30 inches of a handrail. Refer to photo 2.0.4.

2.0.4 Intermediate handrail required

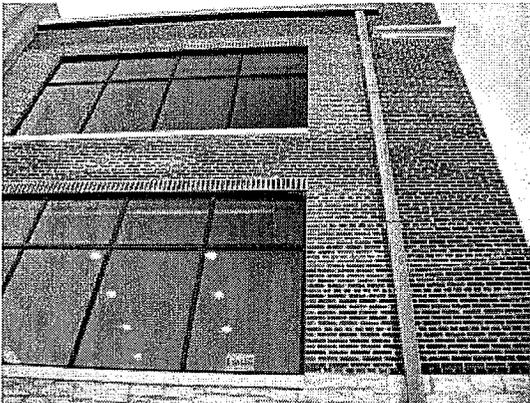
1. Masonry is generally split face limestone at the base of the building and standard brick above. The 1989 vestibule consists of exposed cast concrete at the base and split face CMU above.
2. Multiple past tuck-point projects were observed at both brick and stone areas. The blending of mortar color was poorly done. Refer to photo 2.0.5.
3. Window lintels appear to be sound but need to be cleaned and repainted. Refer to photo 2.0.6.
4. Mortar at stone base was observed to be beginning to spall in places. All masonry faces should be tuck pointed. Refer to photo 2.0.7.

2.0.5 Multiple tuck point projects

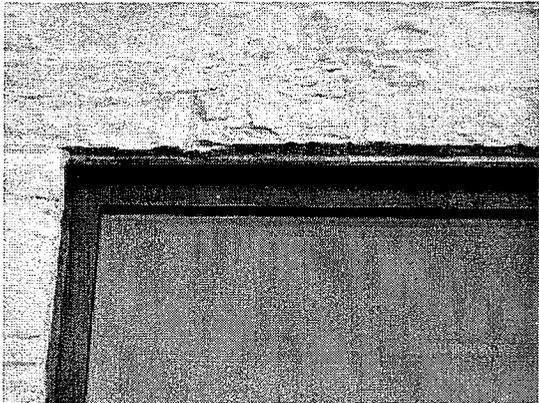
1. Flashing is very limited in the original building. Existing window heads appear to have weep holes but no flashing. Refer to photo 2.0.6.
2. Copings at the parapet appear to be in good condition. Refer to photos 2.0.8 and 2.0.9.

2.0.6 Window lintels need paint

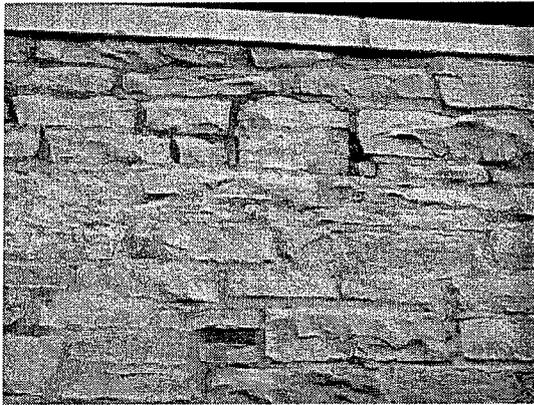
2.0.7 Spalling mortar

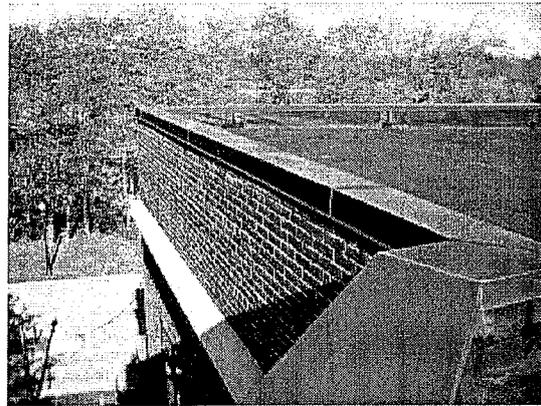
2.0.8 Parapet coping

2.0.9 Parapet coping

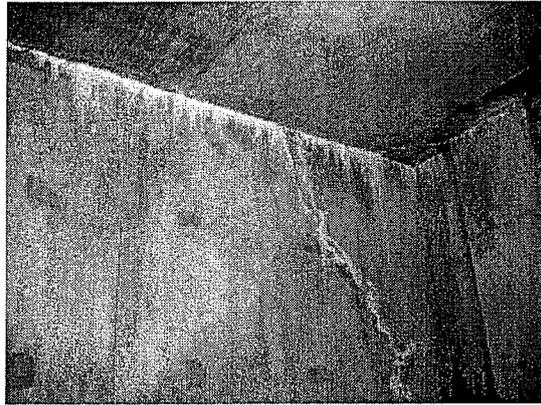
1. Water penetration was observed in the lower level storage room beneath the entry vestibule. The Village Building Inspector noted that water stops were not installed between the foundation walls and the slab above. Refer to photo 2.0.10.

2.0.10 Water penetration beneath vestibule

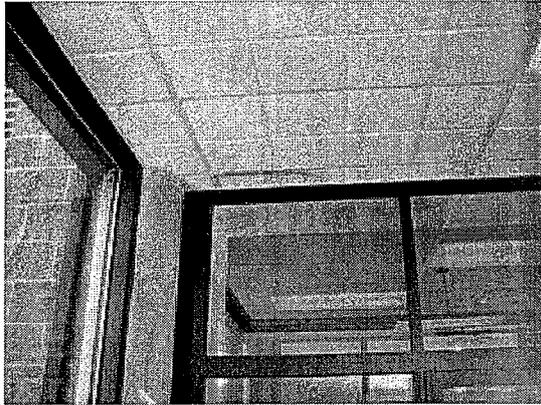
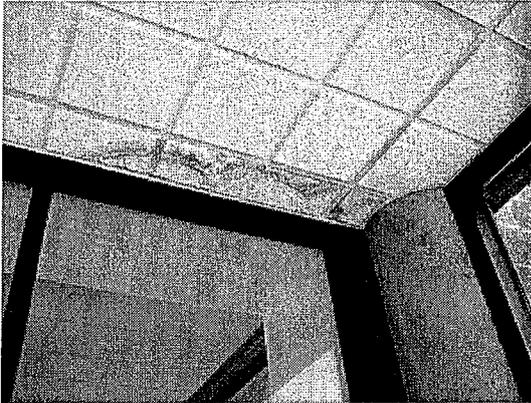
2. Water damage was observed at the junction of the storefront system and the masonry wall at the north side of the vestibule. Refer to photo 2.0.11.
3. Water damage was observed at both sides of the vestibule where the metal roof meets the CMU wall. Refer to photos 2.0.12 and 2.0.13.

2.0.12 Water damage in vestibule

2.0.13 Water damage in vestibule

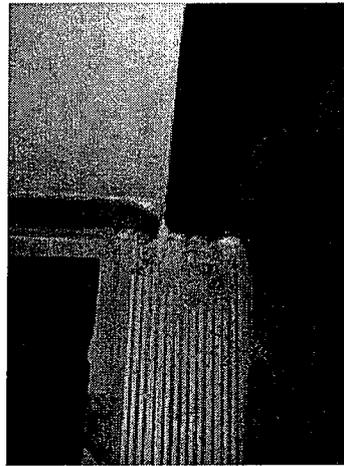
1. Doors and windows were replaced during the 1989 renovation and appear to be in generally satisfactory condition. Window systems consist of insulated glass in an aluminum storefront frame.
2. The lower level courtyard exterior door (adjacent to the meeting room) is showing signs of corroding at the threshold and the base of the frame. Refer to photo 2.0.14.

2.0.14 Deterioration at threshold

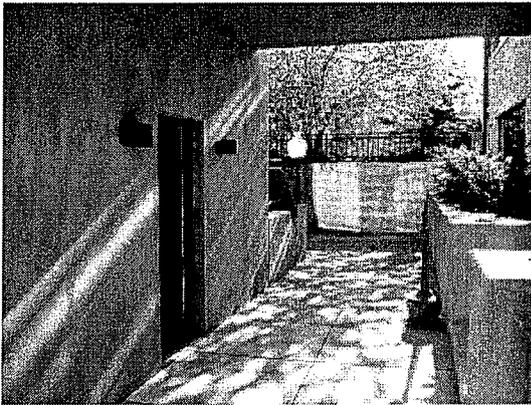
- E. Light fixtures at lower courtyard entrance are not exterior rated fixtures and need to be replaced. Refer to photo 2.0.15.

2.0.15 Wall sconces need to be replaced

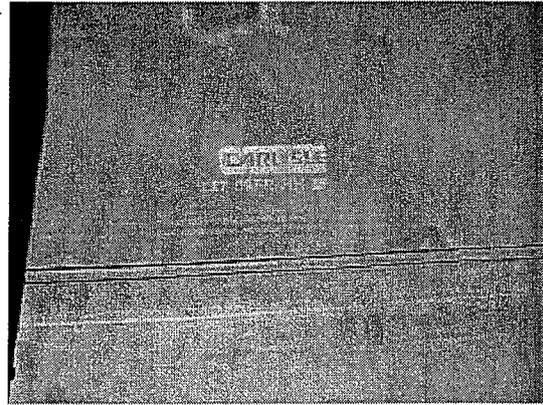
2.0.16 Carlisle roof label

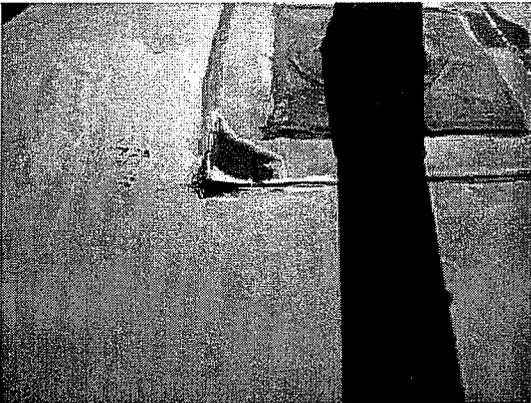
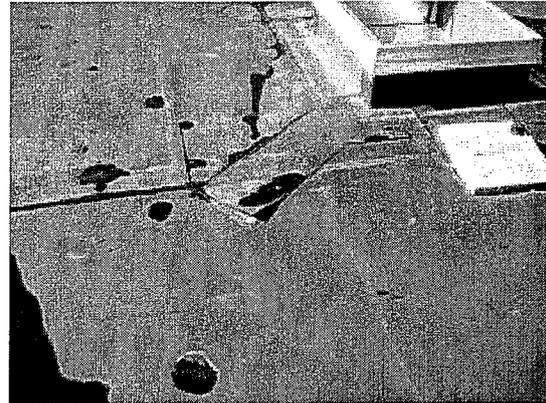
2.0.17 Peeling roof membrane

2.0.18 Peeling roof membrane

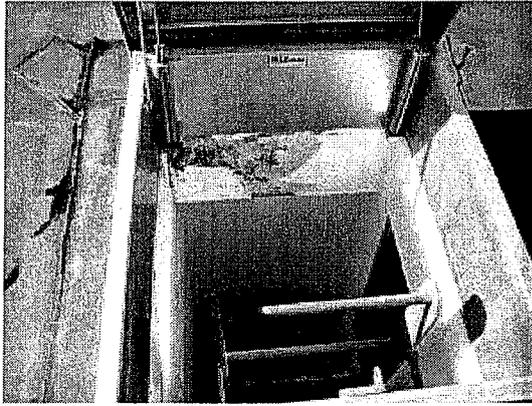
2.0.19 Water penetration at scuttle

12	Repair roof leaks at vesibule	A	1	LS	\$750.00	\$750
13	Repair leaking roof scuttle	A	1	LS	\$1,500.00	\$1,500
14	Replace attic vent louvers	A	9	SF	\$22.00	\$198

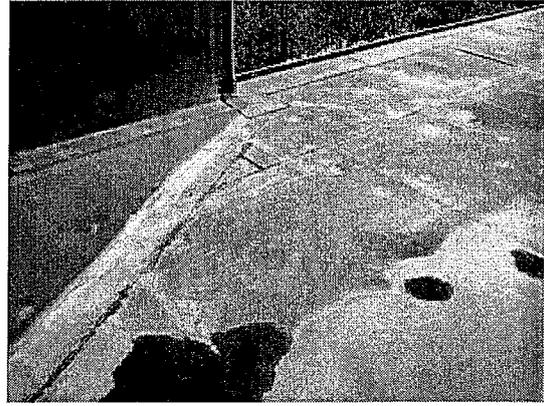
1. The roof appears to now be in generally good condition. The building maintenance director indicated that limited to no maintenance has been performed on the membrane system since its installation in 1989.
2. The roofing system over the main, original building is a Carlisle EPDM fully adhered membrane roof system. Refer to photo 2.0.16.
3. Membrane seams and flashing are beginning to peel back in numerous locations. These are should be repaired as soon as possible to avoid water penetration and further damage. Refer to photos 2.0.17 and 2.0.18.
4. Water penetration was observed at the roof scuttle. Refer to photo 2.0.19.
5. Water appears to be ponding at the east side of the north gable. The insulation below the membrane felt soft when walked on. This are should be monitored for signs of water intrusion. Refer to photo 2.0.20.

2.0.20 Area of ponding water

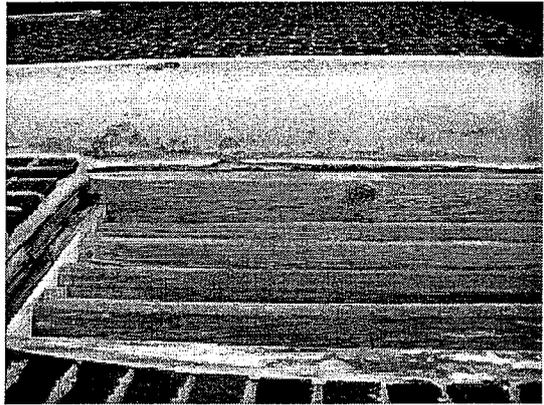
1. The attic space is insulated with blown in mineral wool insulation of varying depth. A vapor barrier was not observed. Refer to photo 2.0.21.
2. Ventilation appears to be provided by a wooden louver unit at the west face of building. The unit is badly deteriorated and must be replaced. Refer to photo 2.0.22.

2.0.22 Wood attic vent louver

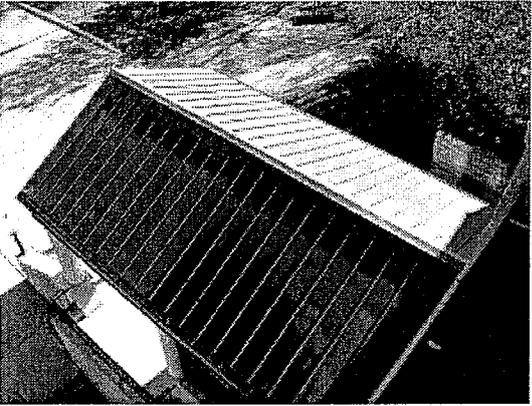
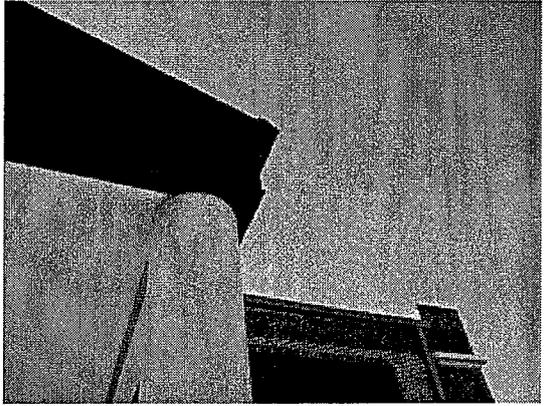
1. Gutters on the standing seam metal roof at the 1989 vestibule addition appear to be inadequately sized and have been damaged by ice. Refer to photos 2.0.23 and 2.0.24.
2. A snow and ice retention system should be installed.

2.0.23 Vestibule roof

2.0.24 Ice damage to gutters

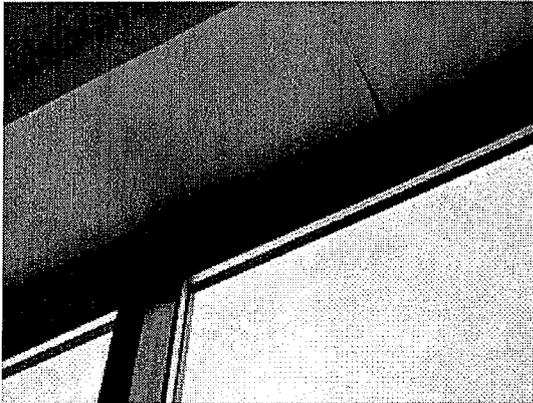
1. Some evidence of water intrusion was apparent around window frames on the second floor. Refer to photo 2.0.25.
2. Some water stained ceiling tiles were observed.

2.0.25 Apparent water intrusion

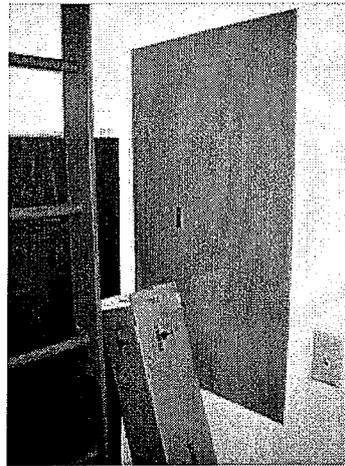
1. Code requires 3'-0" of clear space in front of all electrical panels. The roof access ladder intrudes on this clearance currently. A retractable ladder should be installed to remedy this. Refer to photo 2.0.26.

2.0.26 Electrical panel clearance

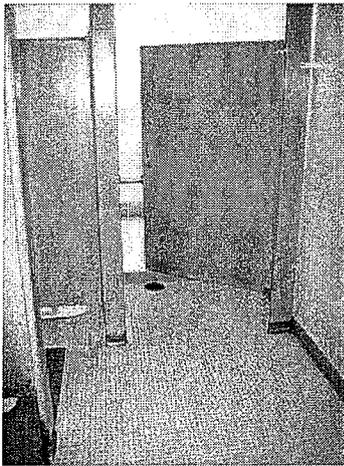
1. All toilet rooms are worn and should be upgraded to comply with current accessibility requirements.
2. Toilet partitions in the lower level toilet rooms are corroding and need to be replaced. Refer to photo 2.0.27.

2.0.27 Corrosion on toilet partitions

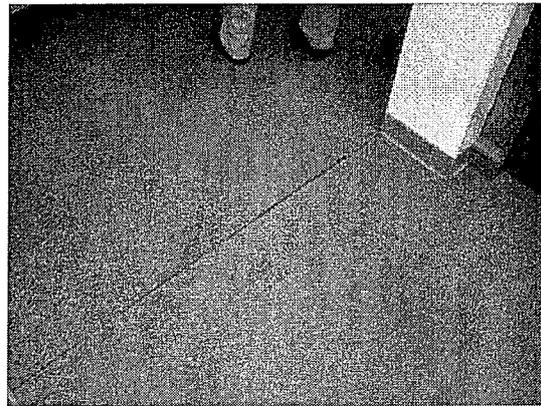
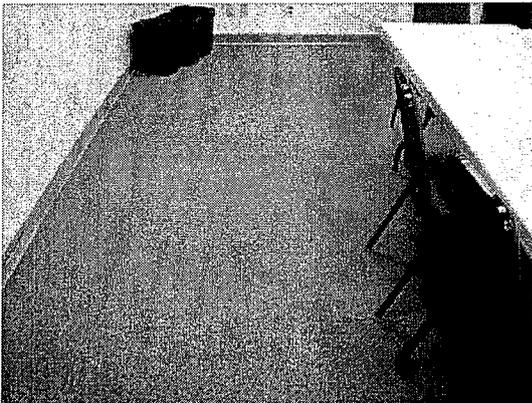
1. Carpet throughout the facility is worn and separating at the seams. All carpet should be replaced. Refer to photos 2.0.28 and 2.0.29.
2. Resilient base was observed throughout the facility. It is in varying states of condition but should all be replaced as part of a larger interior finishes upgrade.
3. Interior walls are primarily painted and in generally good condition. Some general maintenance such as patching and touching up is required. Paint around several window openings was observed to be failing. It was not obvious that this is due to water infiltration but it should be monitored and repaired. Refer to photo 2.0.30.
4. Walls in the former Police area office have vinyl wall covering that is in poor condition. All wall surfaces should be stripped, cleaned and refinished.

2.0.28 Worn carpet

2.0.29 Worn carpet

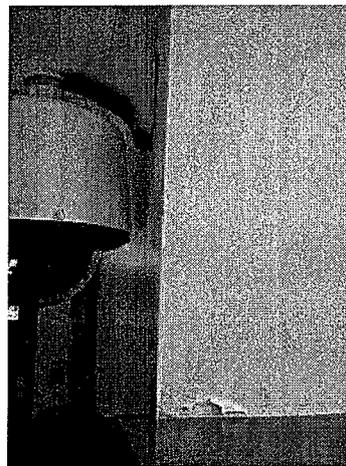
2.0.30 Peeling paint at window

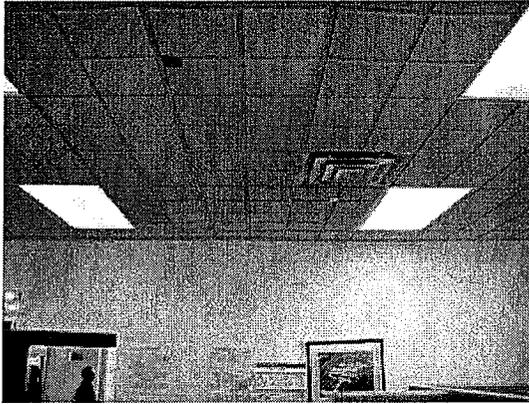
1. Ceiling tile through is beginning to sag. All tile and grid should be replaced. Refer to photo 2.0.31.
2. Light levels should be reviewed for adequacy. Consider replacing older florescent fixtures with more efficient modern units.
3. Outdated incandescent track lighting in cove ceilings should be replaced with more efficient units.

2.0.31 Sagging ceiling tile

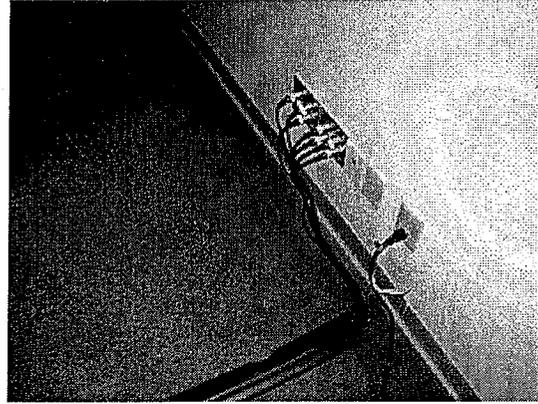
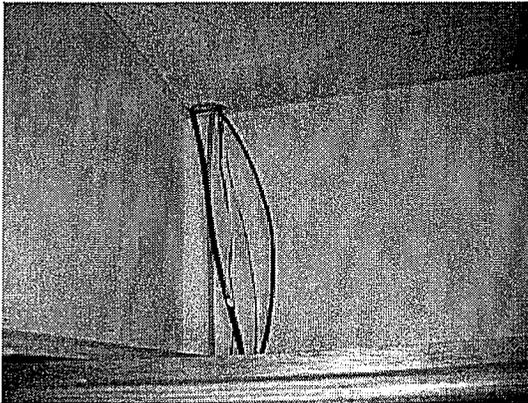
1. Video systems for broadcast of Village proceedings in the meeting room have been added since the building was converted to its present use. Cable and other hardware are exposed on walls and floors. A redeveloped public meeting room should be considered that properly accommodates current broadcast and recording technologies including lighting and acoustics. Refer to photos 2.0.32 and 2.0.33.

2.0.32 Exposed A/V cables

2.0.33 Exposed A/V cables
